Belzona Used on Ferry Water Jet

Ferry water jet propulsion units.

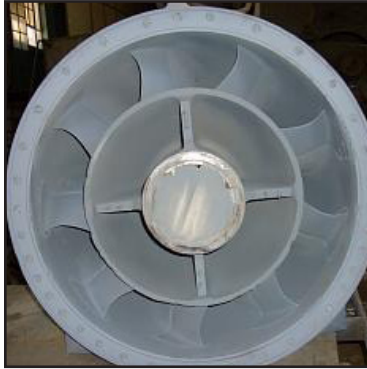
Unit before coating

Units had significant erosion-corrosion.

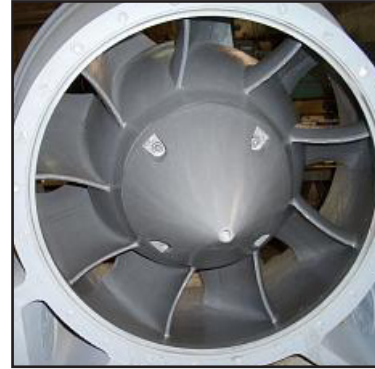
Finished application
