## Belzona Bonds Framework to Oilrig Deck

Support structure (sub frame) for Temporary Living Quarters on Oil Rig.

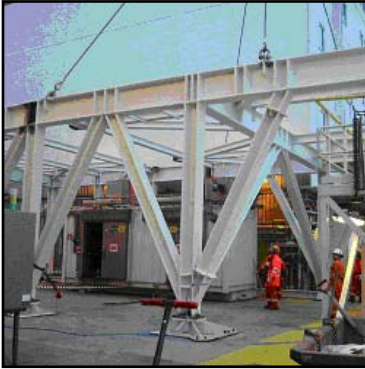
Lowering of sub frame into position and alignment.

The application was carried out in accordance with a modified version of Belzona Know-How System Leaflet GSS-9.

Due to the extended time after alignment/sealing to the bonding phase nitrogen was used to prevent flash rusting in the void to be filled with the Belzona® 5811. To combat the very cold conditions in the North Sea, January (0°C) heat blankets were used to allow the works to be completed.

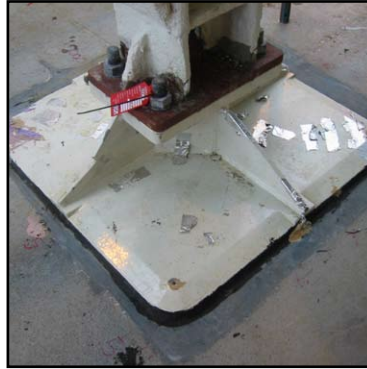
Bonding application completed.

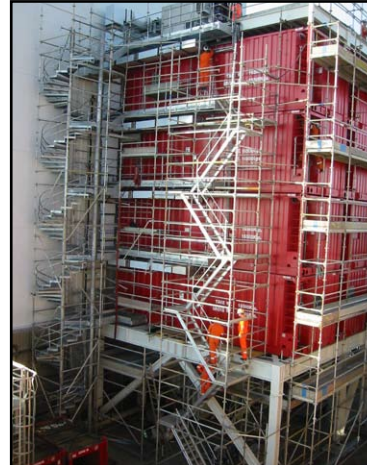
Accommodation Modules in position.
