Tank Base Sealing with Belzona

Coal Fired Power Plant,
Missouri

Large oil tank

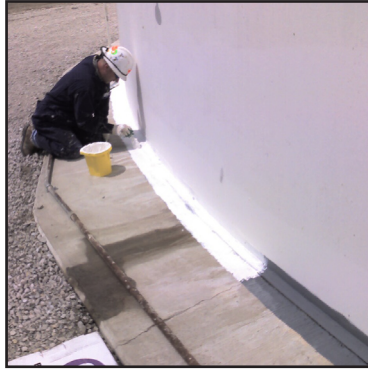
Application underway

Application was carried out in accordance with a modified version of Belzona Know-How System Leaflet GSS-3.

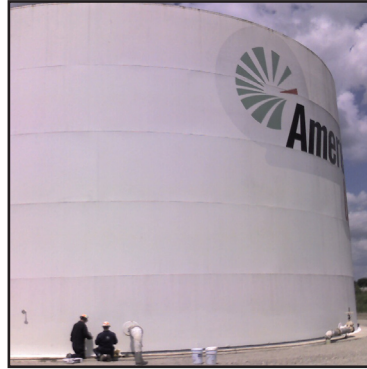
View of tank size
