Belzona Improves Conveyer Efficiency

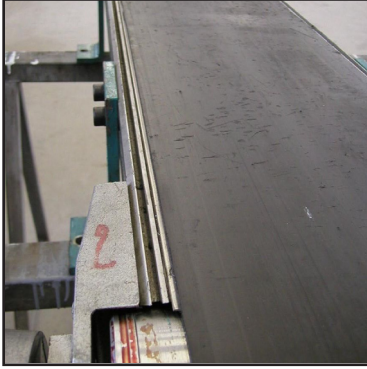
Slippery belt

Products were sliding on the belt due to incline and smooth surface.

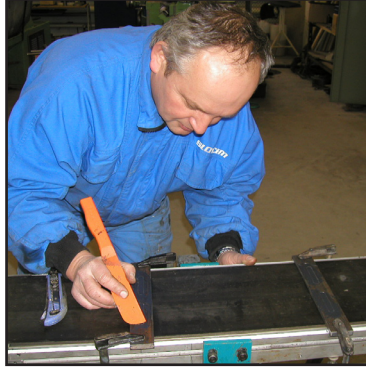
Application of Belzona® 2211

The application was carried out in accordance with modified Belzona Know-How System Leaflet SHM-5.

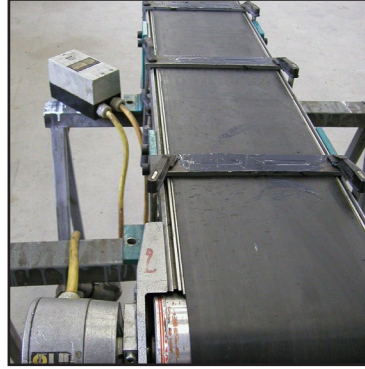
Steel plates moulding Elastomer to shape

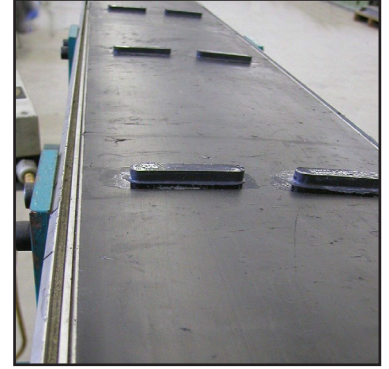
Completed belt ready to work to shape

Customer had problems with sliding of products. To change the belt was expensive. Creating cleats/treads with Belzona was quick, cheap and effective solution.
