Drive Roller Gets Belzona Grip System

Cement plant,
Bulgaria

Conveyor belt drive roll with diameter 1000 mm.

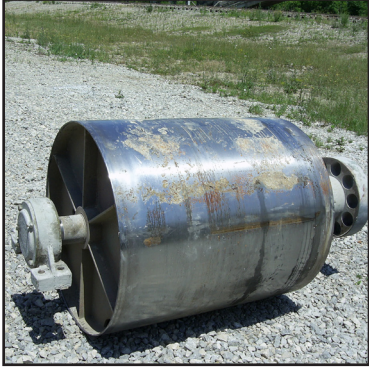
Roller prior to application

The drive roller had no lagging and was exposed to the weather conditions causing loss of grip and slippage.

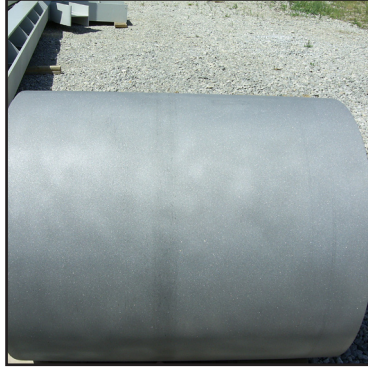
Surface preparation by blasting

Application was carried out in accordance with Belzona® Know-How System Leaflet SHM-12.

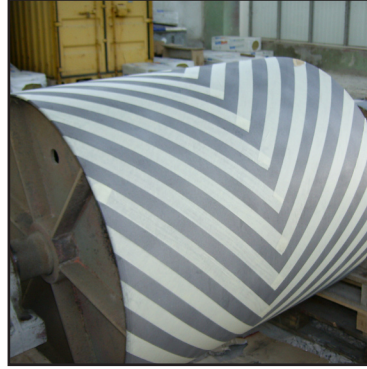
Chevron pattern was created

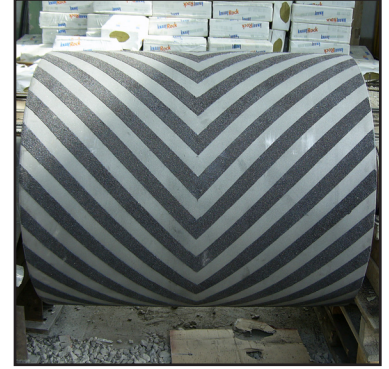
Completed application

Belzona solution was half the cost and faster to apply than conventional hot vulcanization. The roll was prepared and the system applied without leaving the facility. At the end of 2007 the system is still in perfect condition and the client is considering application to another unit.
