Acid Containment Floor Re-Hab with Belzona

Water Treatment Plant,
Oklahoma, USA

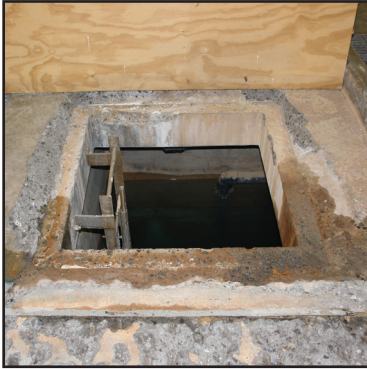
Floor prepared for resurfacing

Caustic and Fluoride spills due to pump leaks had eaten through the floor coating, down to the aggregate in some places, and destroyed the metal framework for the access way into the sump below. Previous coating failed and presented a slippery floor when hosed down.

Application was carried out in accordance with Belzona Know-How System Leaflets FPA-1 & 3. Bulkfill was used to rebuild the sump access and spalled areas. The entire area was then given two coats of Immersion Grade with Surefoot Aggregate applied to achieve safe footing.

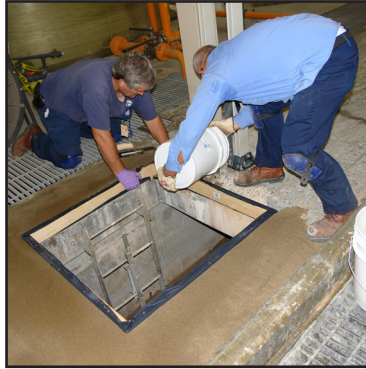
Reshaping the access opening

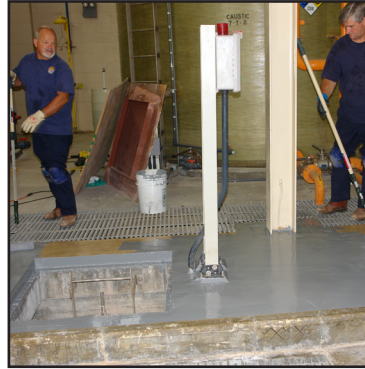
Belzona® 5811 Grey coat over Beige with Surefoot added

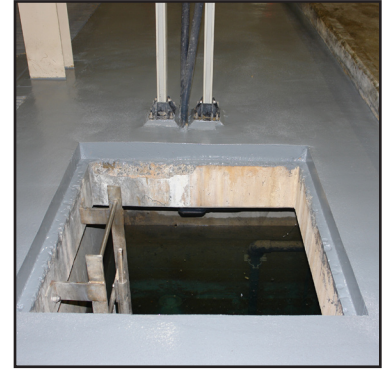
Rebuilt, protected, a first class job
