## BELZONA® SEALS OPEN DRAIN

Chemical Manufacturer (Chromium)-UK

The open drain is a general run-off for rain water on-site.

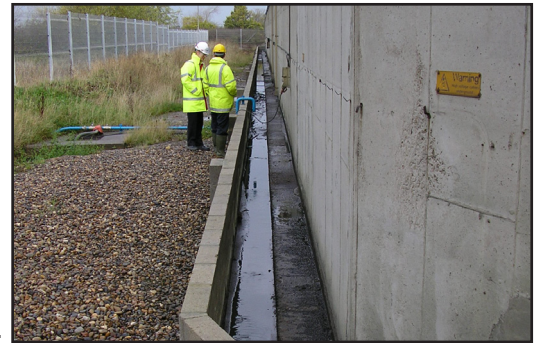
Under heavy rain the drain leaks through the concrete base/block interface & through the porous blocks themselves.

1. General view of open drain
2. Belzona® 5811, first coat.
3. Belzona® 5811, second coat.
4. The completed application.

The application was carried out in accordance with Belzona Know-How System Leaflet TCC-15. The drain was pressure washed to remove any dirt & contaminants and allowed to dry. A fillet of Belzona® 4131 was formed along the base/wall interface followed by two coats of Belzona® 5811.
