BELZONA® PROTECTS CAUSTIC CONTAINMENT AREA

Power Plant, Alabama USA

Caustic Containment Area in water treatment plant.

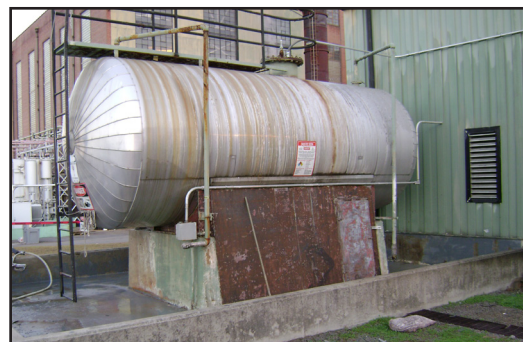
Customers Caustic Containment Area coating had failed and needed a new impervious coating installed.

1. Containment before old coating removed
2. Containment after old coating removed
3. & 4. Completed application

Application was carried out in accordance with Belzona Know-How System Leaflet TCC-15. Old coating was removed using high pressure water blasting. Belzona® 5811 was applied to both containment and tank stands.
