BELZONA® 3211 (LAGSEAL) PREVENTS FUTURE UNDER INSULATION CORROSION

Cement manufacturer - Tunisia

Electro-static precipitators.

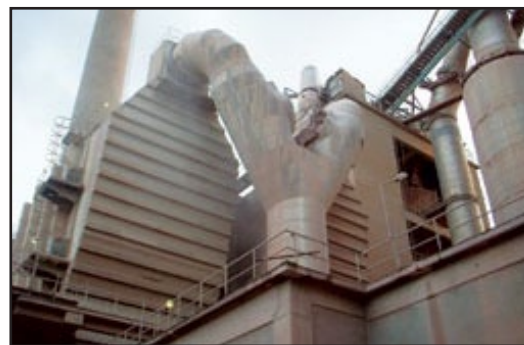
The Electrostatic precipitators at this large cement manufacturer operate at 70kv and 200°C (392°F). As a consequence they are insulated to conserve heat energy. As usual the insulation is protected by the use of jointed steel sheeting which does not prevent moisture from penetrating the insulation layer. The result is under insulation corrosion made worse by the fact that the site is coastal and the atmosphere is salt-laden.

1. View of precipitators.
2. Work begins.
3. View of precipitator's roof.
4. Application complete.

The insulation cladding is completely sealed with the Belzona® 3211 (Lagseal) System. The entire surface except over the pressure relief valves of two of the four precipitators were protected and sealed with Belzona in six days. Each precipitator was nearly 300-square meters in size.
