Belzona Launches Underwater & Oil Tolerant Metal Repair Product

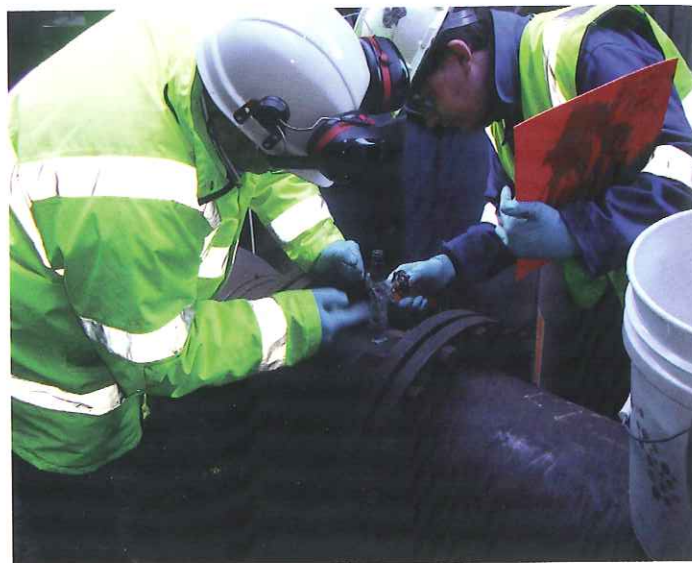
A UK electricity distribution company was faced with a potentially high cost maintenance repair due to oil leakage from transformer pipe work. Traditional repairs involving expensive drain down of the oil were considered too costly in terms of lost power supply. Belzona 1831 (Super UW-Metal) was applied directly onto the leaking pipe work displacing the oil and bonding aggressively to the contaminated surface. To provide long term corrosion protection and prevent further leakage the pipe work was then fully encapsulated in a standard Belzona material. The entire process was carried out in less than two hours which enabled a prompt return to service.
