Thin Paste-Grade Material for Rebuilding Shallow Pitting

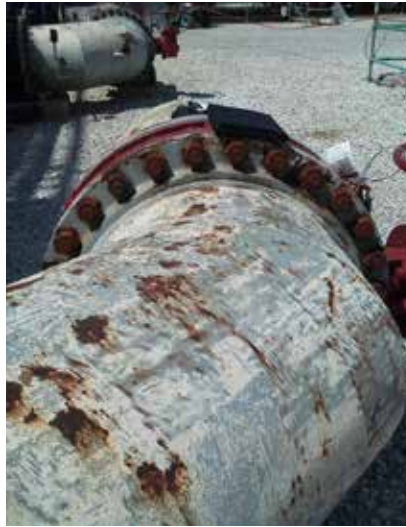
Pitted pipe

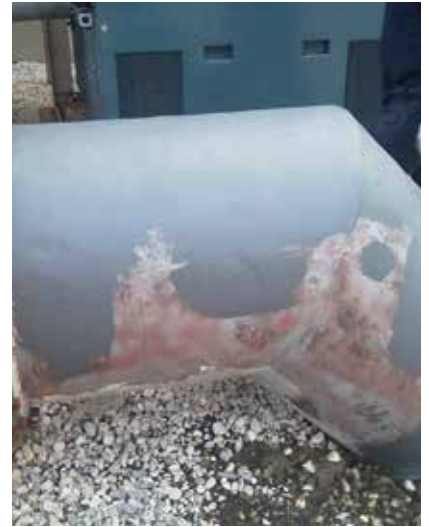
Smooth repair

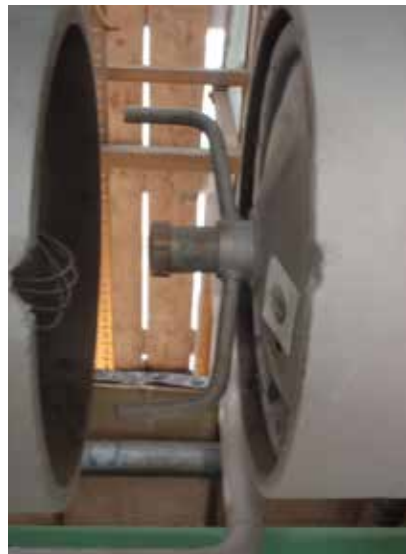
Pitted coupling

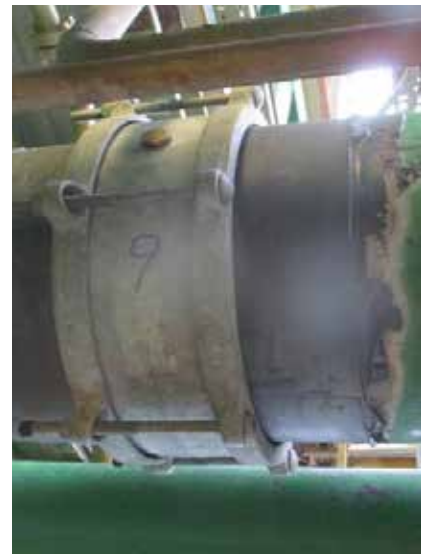
Reinstalled repaired coupling
