Surface Tolerant Multipurpose Repair Material

1212

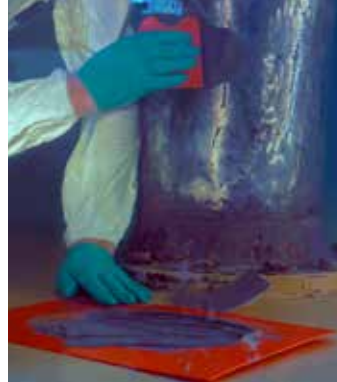
Underwater application

Belzona 1212 can be applied directly onto manually prepared, wet or oil-contaminated surfaces as well as underwater.

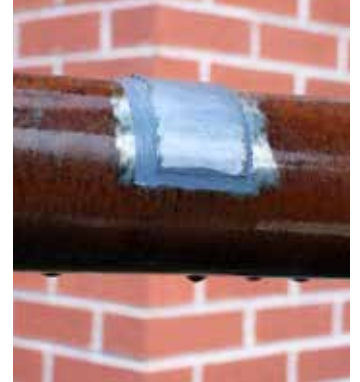
Application to wet, or oil contaminated surfaces

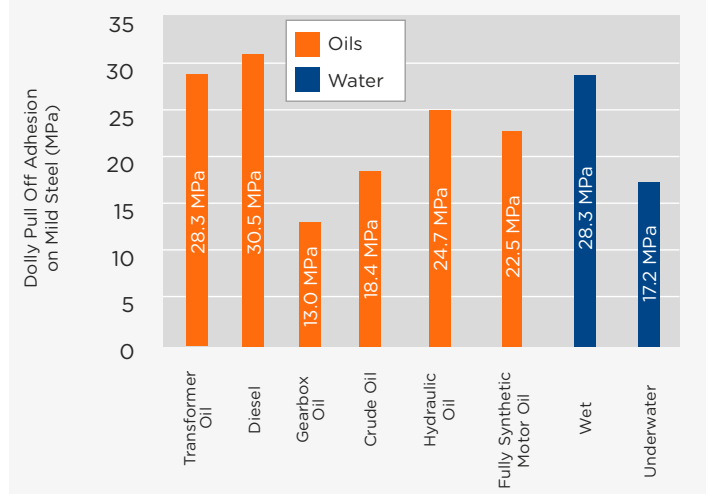
Belzona 1212 demonstrates excellent adhesion to contaminated mild steel surfaces prepared to SSPC-SP11/ISO 8501-1 St3.

Belzona 1212 exhibits high adhesive strength to non-grit blasted contaminated substrates.
