Spray-Applied Protective Coating for Process Equipment Operating at Elevated Temperatures

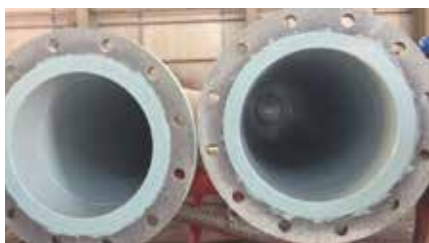
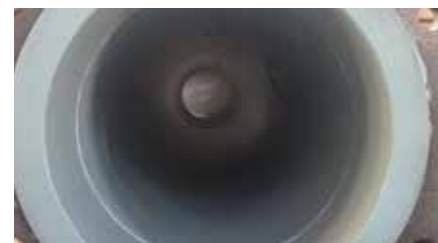
The light colours of Belzona 1523 allow easy visual inspection in vessels.

- Boiler vessels
- Condensers
- Heat exchangers
- Flare knock-out vessels and evaporators
- Separators
