Multi-Purpose, Flexible Repair Composite

Belzona 2211 (MP Hi-Build Elastomer) is a two-component paste grade elastomeric repair composite for the repairing and rebuilding of rubber components.

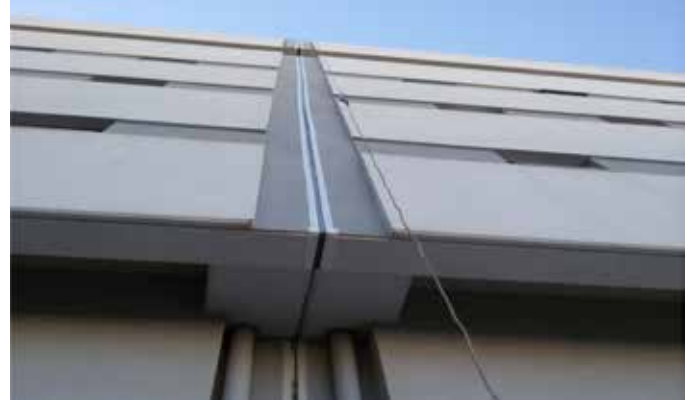
BEFORE

Damaged part rebuilt

Crack and rip repaired

New component cast

Dissimilar material sealed

AFTER
