Emergency Water and Weatherproofing System

Belzona 3121 (MR7) is a two component emergency repair and weatherproofing system for the sealing of almost all types of roof surfaces and structures, even during adverse weather conditions. This liquid-applied material is designed for instant waterproofing and can be applied in year-round weather conditions.

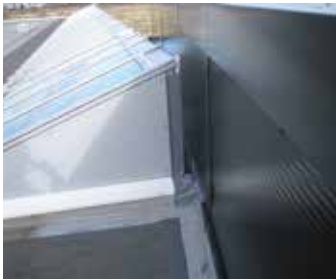
Joints & seams

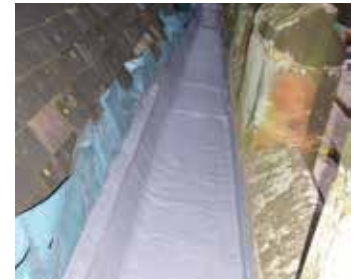
Gutter joints

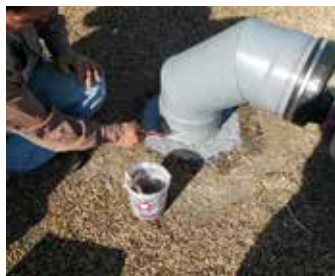
Vents
