Liquid-Applied, Flexible Waterproofing System for Application in Inclement Weather Conditions

Belzona 3131 (WG Membrane) is a cold-applied, single component system which can be used in all weather conditions to provide long-term repair and protection of roofs.

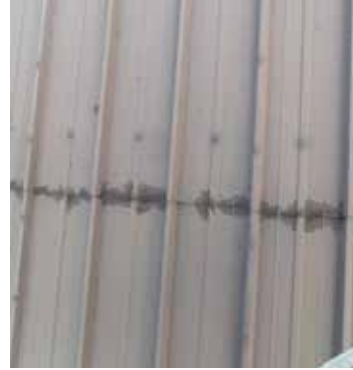
Before

Belzona 3131 used to seal leaks on corrugated steel roof suffering cut edge corrosion.
