Coating for Protection Against Corrosion, Abrasion and Chemical Attack

5111

Belzona 5111 (Ceramic Cladding) is a two-component coating designed for the long-term protection of metallic surfaces and masonry against physical, chemical and bacterial attack.

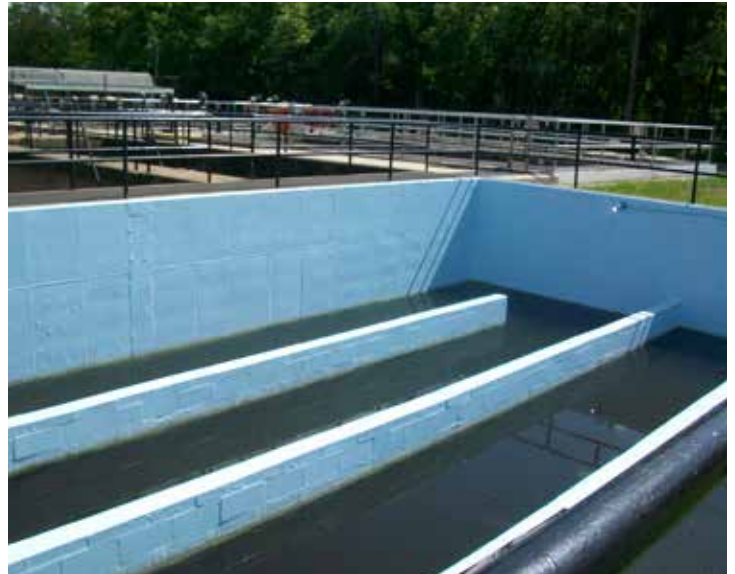
Belzona 5111 used for wall protection of a chlorine tank

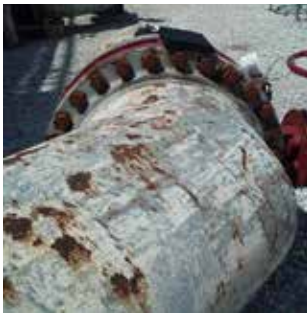
Pipe before

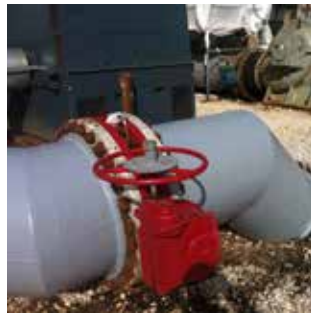
Pipe after

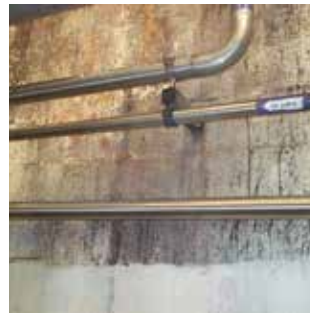
Wall before

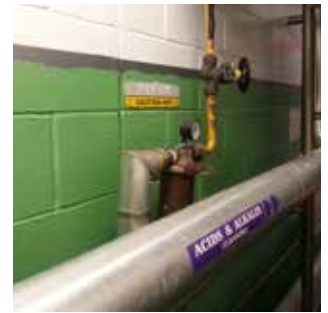
Wall after
