Long-Term Water Repellent Treatment for External Masonry

5122

Belzona 5122 (Clear Cladding) is a water repellent treatment designed to protect brick, concrete and masonry surfaces from water penetration without altering the natural appearance of the structures.

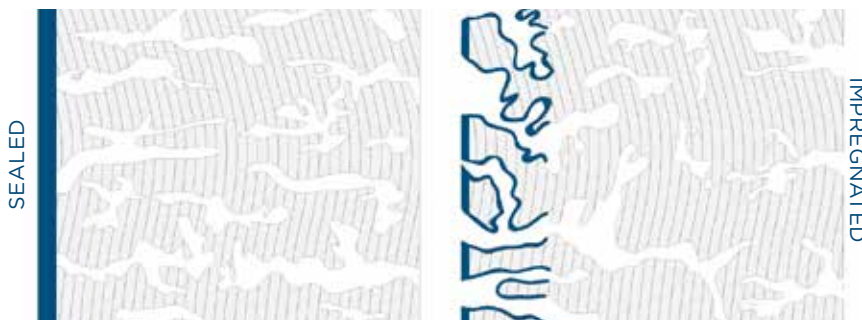
The Difference Between Impregnation and Sealing.

Instead of sealing the substrate, Belzona 5122 impregnates the brickwork, masonry or concrete, combining excellent waterproof protection with the benefit of breathability.

Belzona 5122 impregnates the substrate to form an invisible, microporous layer that still allows air and moisture inside to escape. This helps to avoid the development of damp, mould and damage to insulation.
