Moisture-Tolerant Protective Barrier Coating

5831

Belzona 5831 (ST-Barrier) is an environmental moisture-tolerant barrier coating for the protection of metallic and non-metallic surfaces.

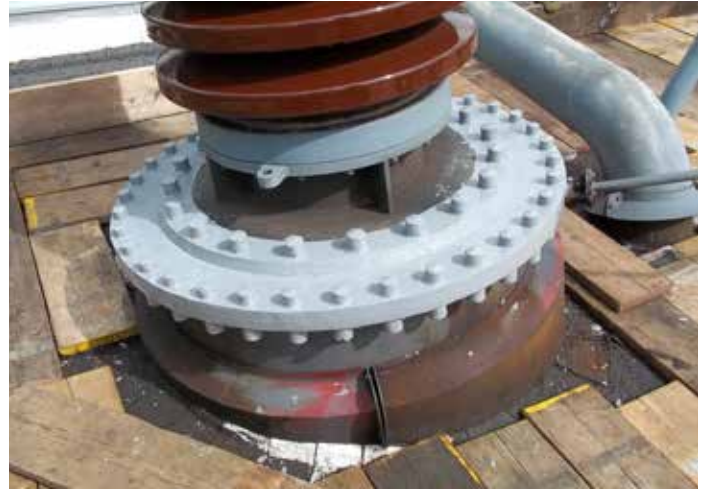
Belzona 5831 used for transformer oil leak sealing
