# Composite Repair System

Belzona SuperWrap II is a composite repair solution designed to restore strength to weakened or holed metallic substrates. Developed for applications on pipes and process vessels, it is also suitable for safety critical and pressurised systems, and can be used on bends, tees and other complex geometries.

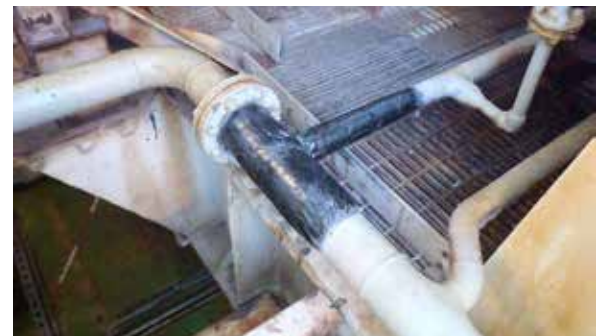
## Belzona SuperWrap II Components:

Belzona 1981, Belzona 1982 or Belzona 1983

Glass and carbon fibre blend reinforcement sheet

Release film for wrap consolidation
