Composite Repair System

Belzona SuperWrap II is a composite repair solution designed to restore strength to weakened or holed metallic substrates. Developed for applications on pipes and process vessels, it is also suitable for safety critical and pressurised systems, and can be used on bends, tees and other complex geometries.

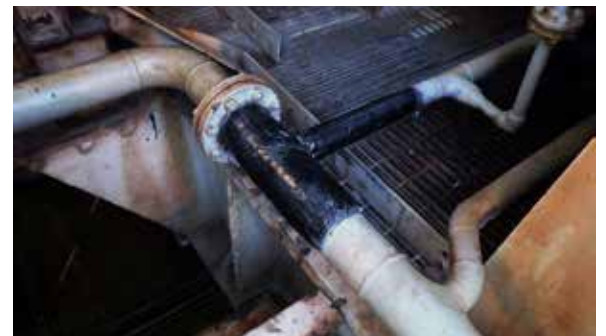
Belzona SuperWrap II Components:

- Choice of resin

Belzona 1981, Belzona 1982 or Belzona 1983

- Belzona 9381

Glass and carbon fibre blend reinforcement sheet

- Belzona 9382

Release film for wrap consolidation
