Industrial Coating for the Protection of Floor Areas

Belzona 5231 (SG Laminate) is a two-component, liquid-applied coating system, designed for floor areas where chemical, abrasion and slip resistance are required.

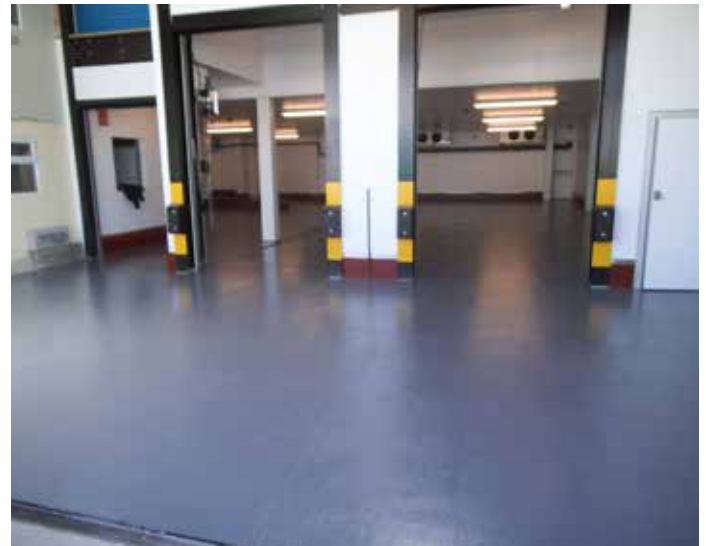
Dairy warehouse floor restored with Belzona 5231

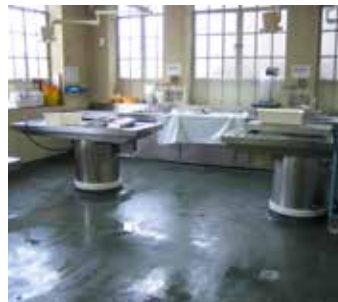
Concrete floor before

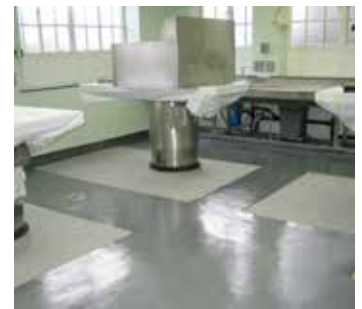
Concrete floor after

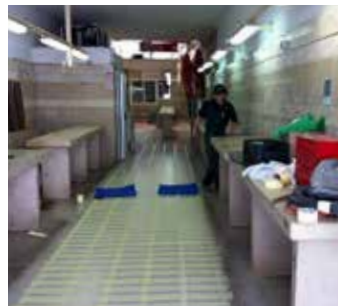
Tiled floor before

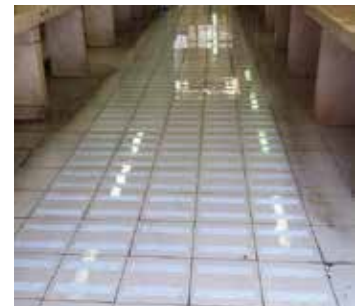
Tiled floor after
