# Thermal insulation barrier providing corrosion protection with “cool-to-touch” properties

# 5871

Belzona 5871 is a novel, two-component, polymeric, solvent free system providing a thermal insulation barrier with corrosion protection and thermal and sub-zero “cool-to-touch” properties.

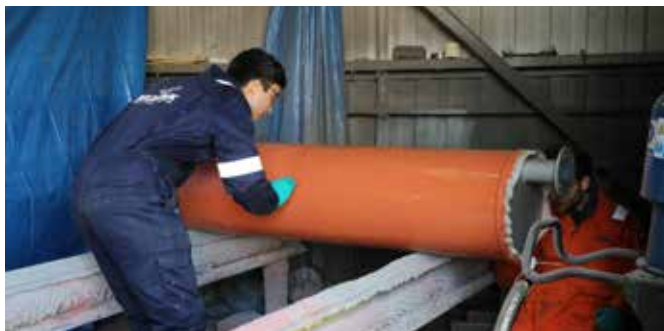
Application onto a seal pot
