# Fast Curing, Surface Tolerant, Abrasion Resistant System for Patch Repairs

**BELZONA®**  
**1818**

Belzona 1818 is a fast curing, surface tolerant, abrasion resistant system ideal for patch repairs on surfaces subject to high erosion and abrasive environments.

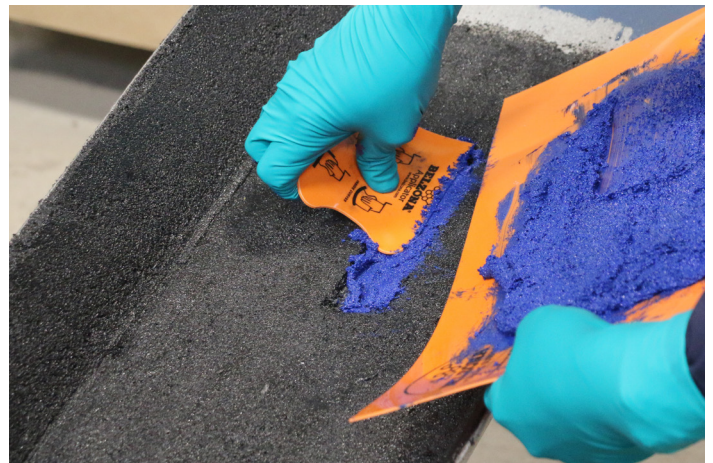
As shown in the image above, Belzona 1818 is ideally suited for patch repairs where a rapid return to service is required.
